# **EXHIBIT O**

## ETHICO N,INC.

September 30, 1987

IR MICROSCOPY OF EXPLANTED PROLENE\*
RECEIVED FROM PROF. R. GUIDOIN

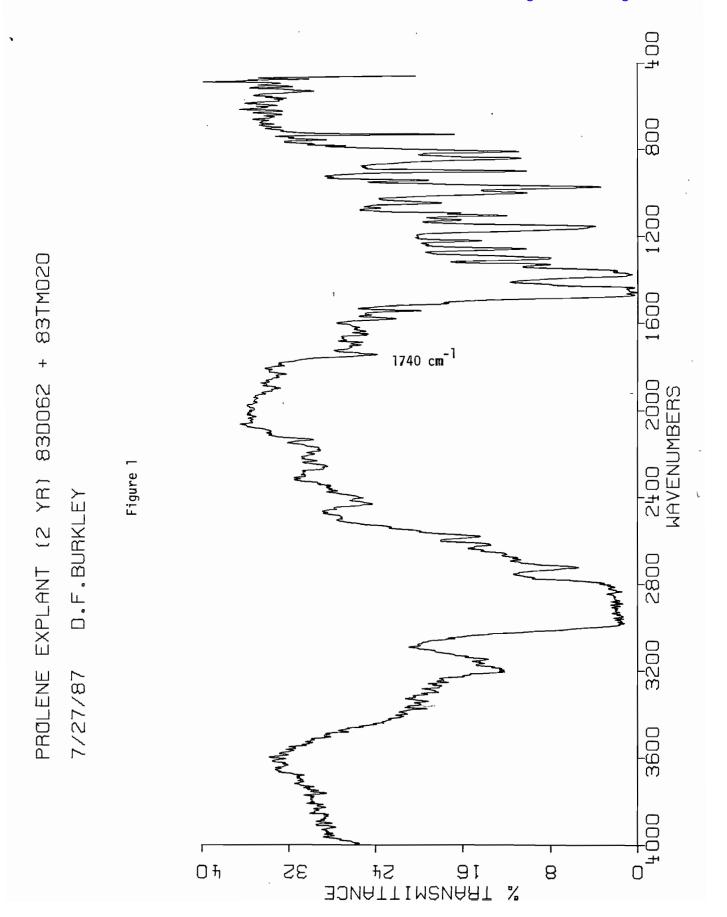
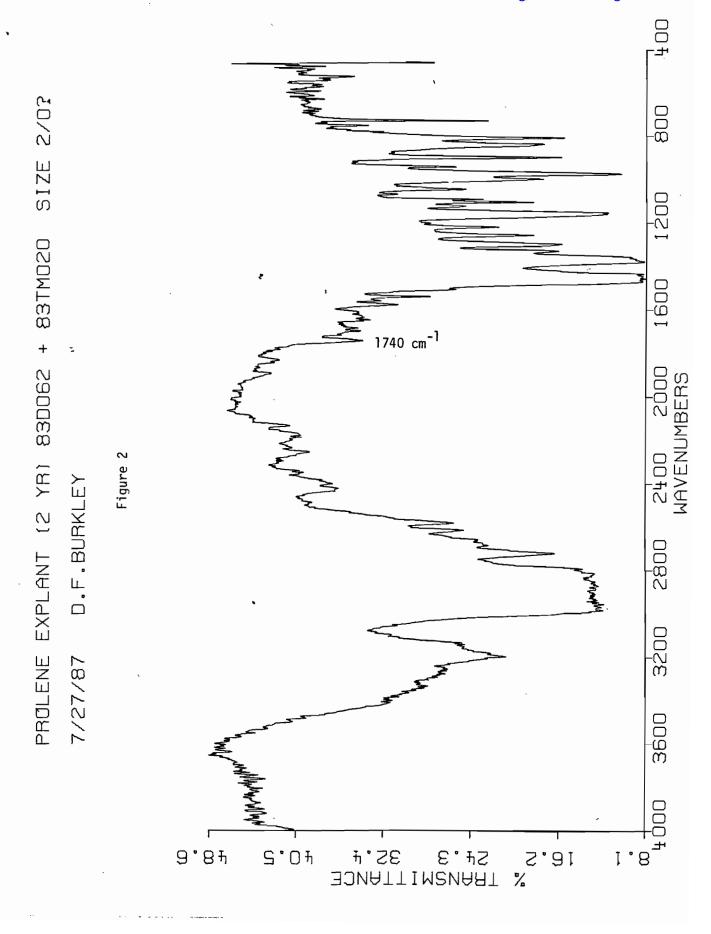
<u>Sample</u>	Implant <u>Duration</u>	Microscopy Observations <u>(SEM- F. Schiller)</u>	IR Spectra (Figure #)
83D062 + 83TI9020	2 yr.	No cracking	1,2
830035	8 yr.	Severe cracking	3,4,5,6,7
TB2418-Q Sterile Prod	Non-implanted duct control		8,9

Spectra of samples examined "as is" show remarkable similarity between explanted suture and unimplanted suture. All major polypropylene and pigment bands are observed (Figure 9). The 1740 cm<sup>-1</sup> band, seen strongest in the sterile product, is due to dilauryl thiodipropionate (DLTDP) additive. The DLTDP appears reduced in the 2-year sample spectra and further reduced in the 8-year sample spectra. DLTDP is not observed in the surface scraping spectra.

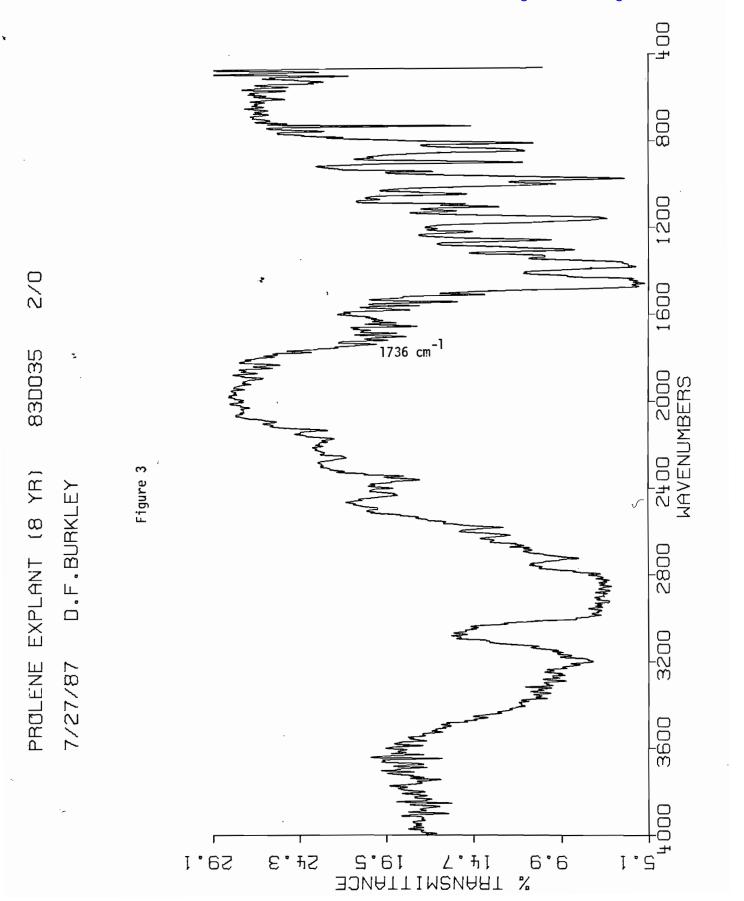
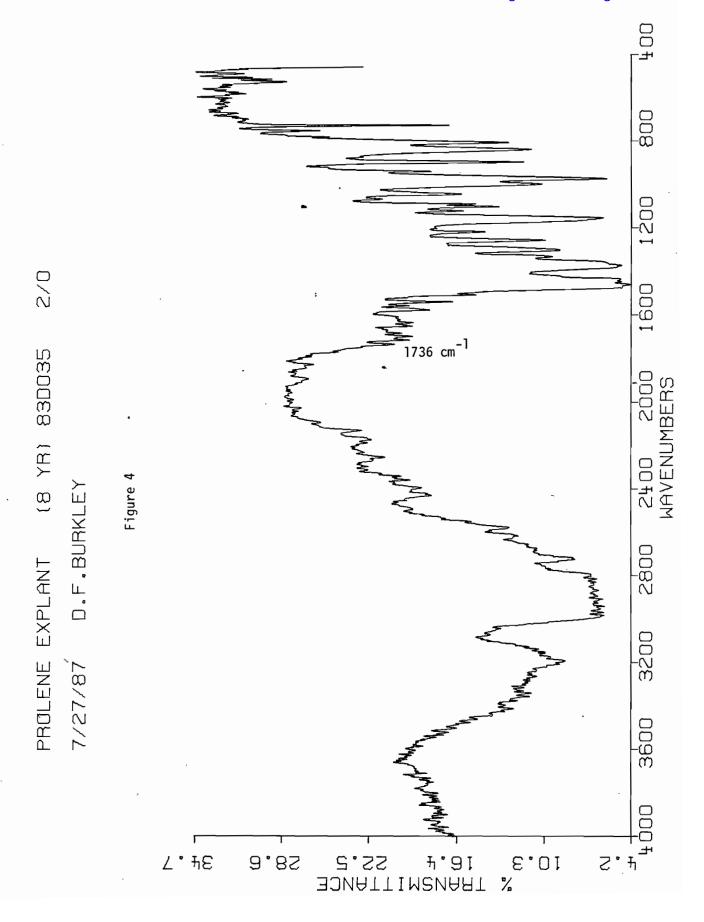
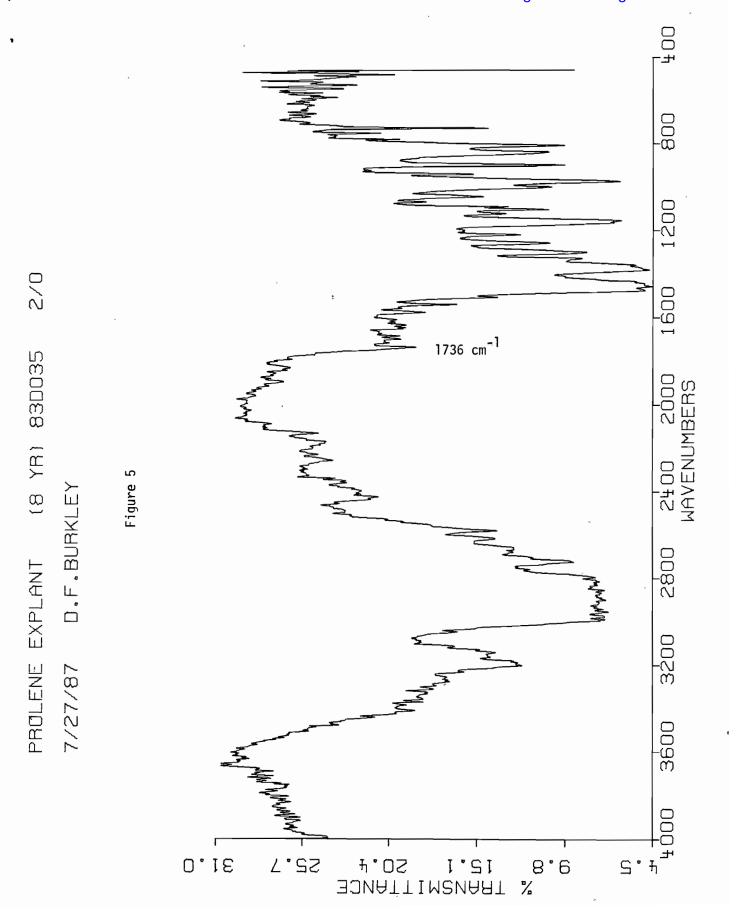
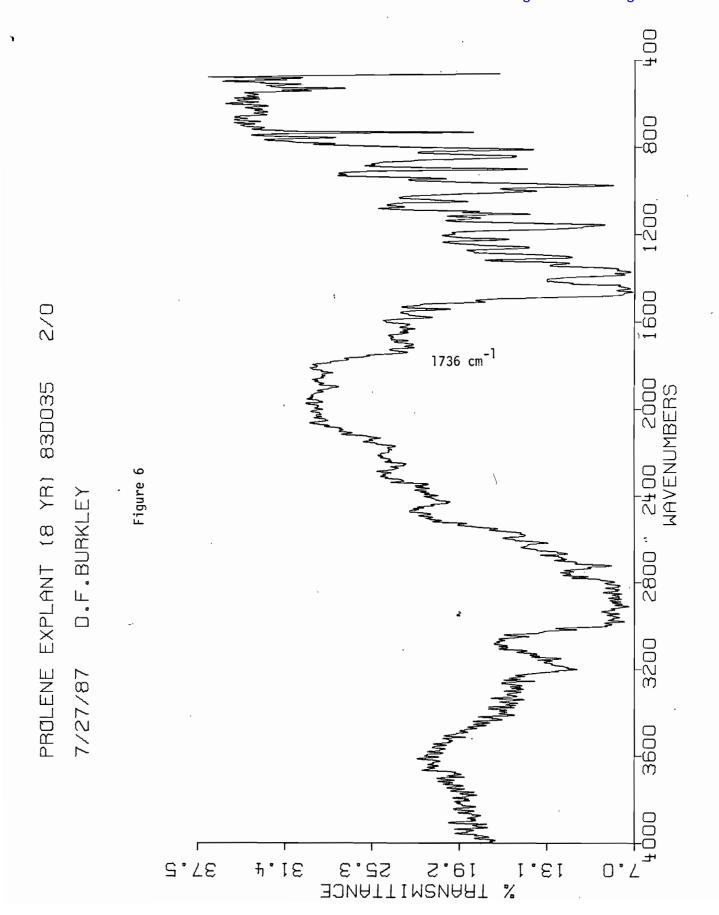
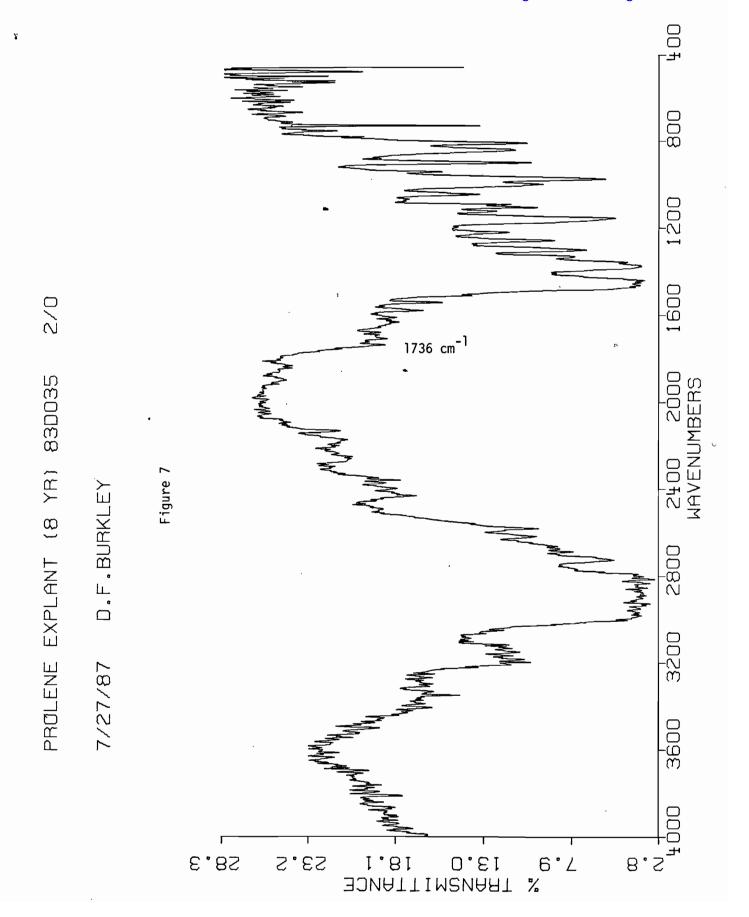
The samples were examined "as is" with no special preparation. Multiple spectra were obtained at different sites along the explants, especially for the 8-year severely cracked specimens. The IR spectra appear "bottomed out" since the sample thickness is quite significant.

Some samples of 83D035 (8 yr.) were examined optically. Using a needle, the cracked surfaces were easily wiped off and deposited on a KBr window. The surface "scrapings" had the handling and consistency of a waxy snow. The sample was not conducive to IR microscopy in this form however. Similar treatment with needles on sterile packaged PROLENE and the 2-year sample generated no scrapings.

The observation of chemical species in the surface scrapings spectra of 83D035, yet not seen in the "bulk" spectra (surface + interior) of the suture explants, suggests that the regions affected by cracking or degradation are very small relative to the entire suture. The surface scraping spectra are very different from the "bulk" spectra, and both types of spectra show no evidence of the presence of protein.

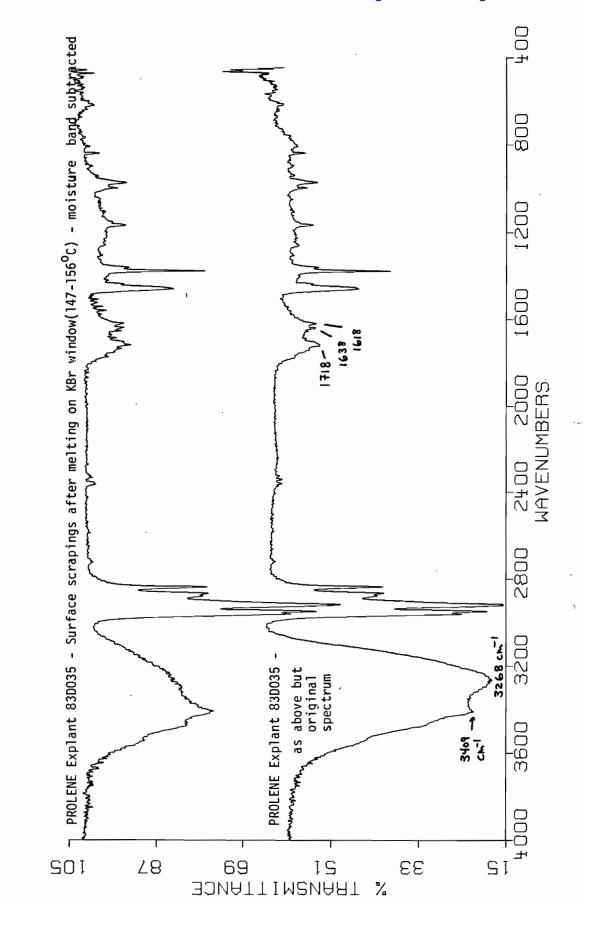
The surface scrapings of 83D035 were melted at 147°-156°C on the Mettler hot stage. This is the melting range previously observed for oxidatively degraded polypropylene. IR microscopy of the melted film produced (Figures 10 & 11) yielded good spectra.

The surface scrapings spectra of 83D035 clearly indicate polypropylene, but also three or four other broadened bands. Table I explains the possible functionalities determined from a library search of the IR bands not normally seen in polypropylene.

- The amount of DLTDP is reduced in the explanted sutures. No DLTDP is observed in the surface scraped (cracked regions) of 83D035. The observed DLTDP decreases with implant time.
- 2. No protein is observed in any spectra of the explanted sutures.
- 3. The surface scraped material from the cracked regions of 83D035 has a melting range indicative of degraded polypropylene. The IR spectra of this scraped material is clearly polypropylene, but it appears to be degraded in an oxidative fashion. There are a number of degradation species possible from the IR data. Hydroxyl and acid/ester functionality are definitely present. Ketone and/or unsaturated species are suggested, but not verified.
